# Electrochemical response of scratched Alloy 600 in simulated primary water and its influence with hydrogen entry

The effect of scratches on oxidation evolution of Alloy 600 was monitored by EIS in 290°C simulated primary water. EIS result indicates that oxide film reached a stable condition until 7 days' immersion. The scratched Alloy 600 possessed almost the same evolution of oxide film with plain specimens. Anodic polarization was performed to study combined effect of scratches and charged hydrogen. The anodic current changes of scratched Alloy 600 after hydrogen charging were not the simple superimposition between that of scratched and charged plain Alloy 600. Alloy 600 after scratching was supposed to trap more hydrogen because of introduction of cold work. The trapped hydrogen could accelerate the oxidation by enhancing dissolution of chromium oxides. Thus, the oxides became less protective and anodic current increased considerably over more noble potential range.

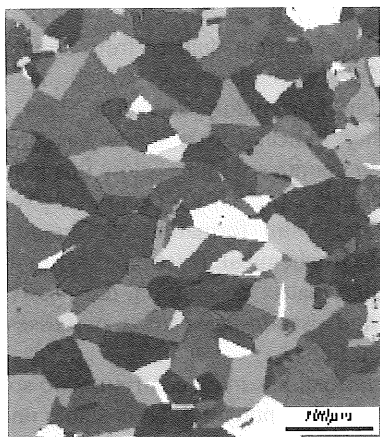
The microstructure of this heat after electro-polish was characterized using electron backscatter diffraction (EBSD) as shown in Fig.1. EBSD measurement was conducted on Hitachi S-4300 FE-SEM, which equipped with solutions camera control system made by TSL, Co. Ltd. The data was collected and analyzed by OIM<sup>TM</sup> Software. The grains were about 80 $\mu$ m.

Fig.1. EBSD observation of Alloy 600

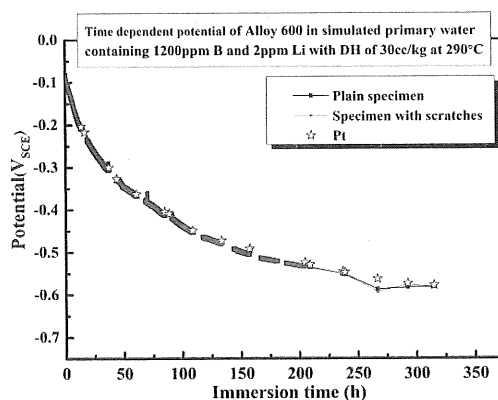
Fig.2. Time dependent potential of Alloy 600 in simulated primary water at room temperature, during heating up and at 290°C

The time dependent potentials for plain and scratched Alloy 600 were shown in Fig.2. For these two specimens, the potentials all dropped negatively during the whole monitoring process. At the start of the test, the potentials

shifted negative dramatically. It took about 7 days to reach a stable value in the simulated primary water with a DH 30cc/kg, which means that oxide formation and matrix dissolution needed longer time to get a balance. Measurement of anodic polarization in less than 7 days' immersion may not reflect the electrochemical behavior of long-term service of Alloy 600. However, there seems to be no difference for the corrosion potential between scratched and plain specimens.

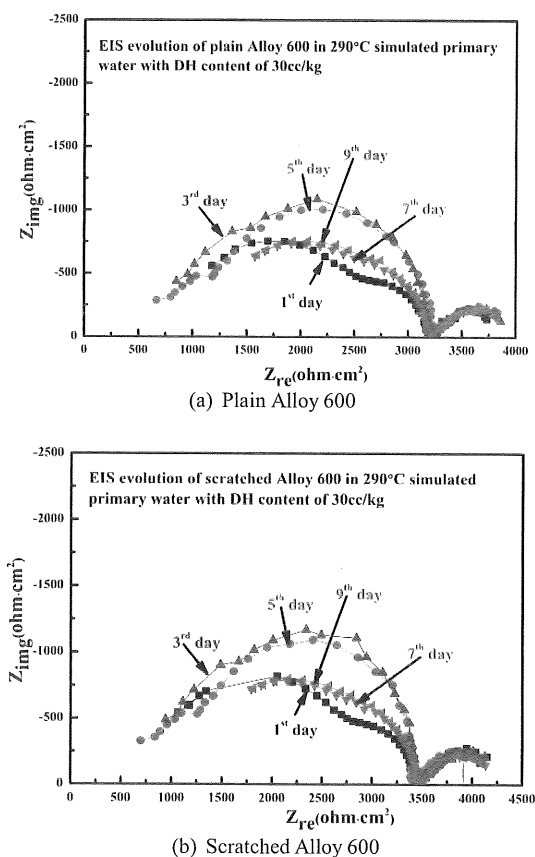
During potential monitoring, EISs both for plain (Fig.3a) and scratched (Fig.3b) Alloy 600 were traced every two days. For the low frequencies impedance arc in Fig.3 which stands for the electric double layer, there were no obvious differences between plain and scratched Alloy 600 with increasing immersion time.

Fig.3. Evolution of Nyquist diagrams for plain and scratched Alloy 600 in simulated primary water

However, significant difference can be found in the high and intermediate frequencies impedance arc as shown in Figs.3a and 3b. This part of impedance arc can reflect characters of oxide film. It is noteworthy that there is no persistent increase of imaginary part during the evolution of oxide film in the simulated primary water. The imaginary part in high and intermediate frequencies dropped after 5 days' immersion. Oxides became more stable from 7th day and Nyquist diagram did not change a lot from that time on. This is consistent with the result of potential monitoring.

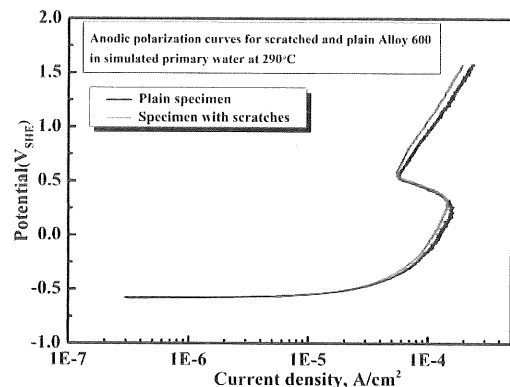
The polarization curves for plain and scratched Alloy 600 were shown in Fig.4. Even though Alloy 600 was scratched, there was no apparent effect on anodic behavior compared to plain Alloy 600. The identical character may be caused by dissolved hydrogen. The dissolved hydrogen can easily enter into the alloy 600 matrix [7]. Because of the uniform hydrogen in the aqueous environment, surface distribution of hydrogen permeated into the oxide film and matrix was supposed to be homogeneous in both kinds of specimens. At corrosion potential, dissolved hydrogen can partly reduce the surface film and the film toward corrosion for both scratched and plain Alloy 600. The high anodic current also suggests that matrix dissolution was not restrained even though there covered oxide film on the surface. Scratching brought about a heavy plastic deformation to the surface, but dissolved hydrogen as the leading role, suppressed the effect of scratches on the surface.

Fig.4. Anodic polarization curves for plain and scratched Alloy 600 in simulated water containing 1200 ppm B and 2 ppm Li at 290°C.

A decrease of current density from about +0.2V/SHE to +0.6V/SHE was observed, which is not a real passivation but a pseudo-passivation. This decrease of current density indicates that there was pre-passivation process during anodic scanning below this potential range. The competition probably occurs between matrix dissolution and film formation at anodic potentials. When the electrochemical reaction of film formation is more rapid than matrix dissolution, pre-passivation below +0.2V/SHE and pseudo-passivation processes take place as presented in Fig.4.

According to B.T. Lu et al. [12], the synergistic effect due to the interaction of charged hydrogen and local stress field is negligible. In present test, the superimposition of dissolved hydrogen in the primary water and scratch-induced local stress field can be ignored as indicated in Fig.4. However, the charged irreversible hydrogen caused by scratching have a strongly interaction with active dissolution of Alloy 600.

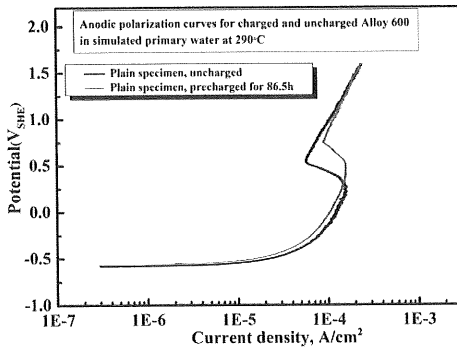
After hydrogen charged in simulated primary water, Fig.5 shows the anodic polarization curves obtained from plain Alloy 600. To some extent, the current density at pseudo-passivation zone for the charged specimen increased, i.e., the formation of compact oxide film, which has been discussed in Section 3.1.2, was retarded.

Fig.5. Anodic polarization curves for plain Alloy 600 after charging in simulated water containing 1200 ppm B and 2 ppm Li at 290°C.

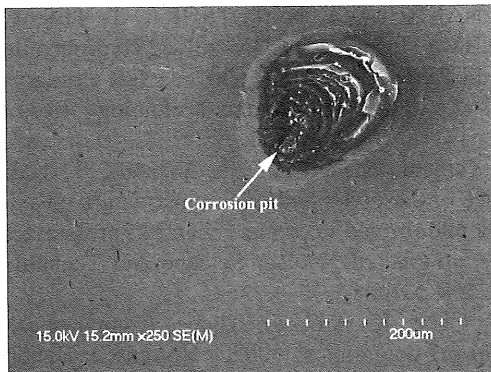
Fig.6. SEM micrograph revealing the surface corrosion pit of 86.5h hydrogen charged plain Alloy 600 after anodic polarization

Fig.6 depicts the optical micrograph of hydrogen charged Alloy 600 after anodic polarization in simulated high temperature primary water. It was found that a corrosion pit appeared on the surface. This extra

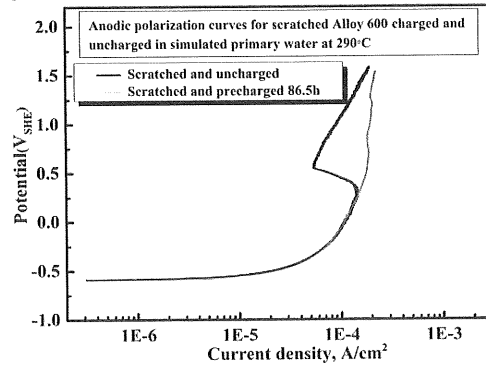
Anodic polarization curve for scratched Alloy 600 (Fig.7) was measured after hydrogen charging for 86.5h in simulated primary water, too. The pseudo-passivation zone over +0.3V/SHE after hydrogen charging, compared to the uncharged but scratched one, disappeared.

Fig.7. Anodic polarization curves for scratched Alloy 600 after hydrogen charging in simulated water containing 1200 ppm B and 2 ppm Li at 290°C.

The anodic current over +0.2V/SHE for scratched Alloy 600 was not related to increased potential, which implies that anodic dissolution was controlled by diffusion. The irreversibly trapped hydrogen in cold worked Alloy 600 can be as high as 6ppm at this test temperature [7], which was higher than the dissolved hydrogen (about 2.67ppm) in the simulated primary water. The irreversible hydrogen was sufficient to inhibit formation of oxide film such as  $\text{NiCr}_2\text{O}_4$  and  $\text{NiFe}_2\text{O}_4$  and quickened anodic dissolution by oxidizing  $(\text{Fe,Cr})_2\text{O}_3$  and  $\text{Cr}_2\text{O}_3$ . As displayed in Fig.8, a lot of corrosion pits appeared at two banks of scratch and the scratch groove. The pits illuminate that the protective chromium oxide was also dissolved.

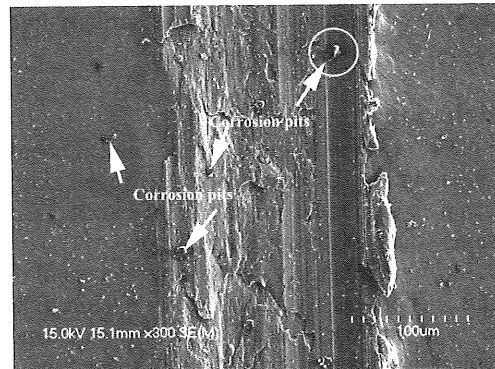
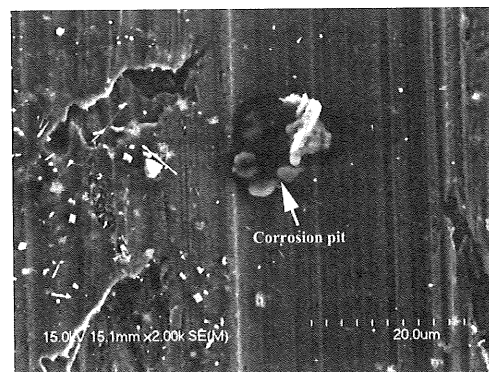
(a) Top view of a scratch

(b) Marked area in (a) with a high magnification

Fig.8. Surface observation of 86.5h hydrogen charged Alloy 600 with scratches after anodic polarization
